Manhole Inspection Summary

Manhole # S09QQ_018MH

Insp Date: **8/7/09 10:37 AM**

Location Address: **DENISON AVE ALLEY**

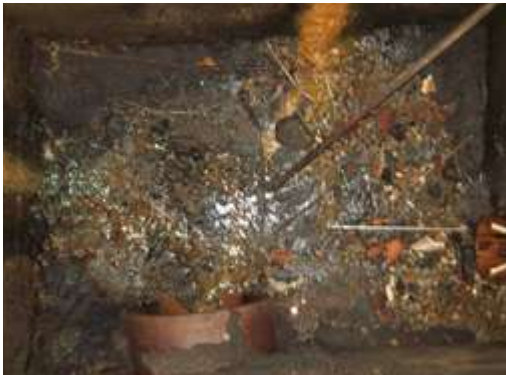
The Top View Cannot Show the Connectivity Due to the Rectangular Barrel

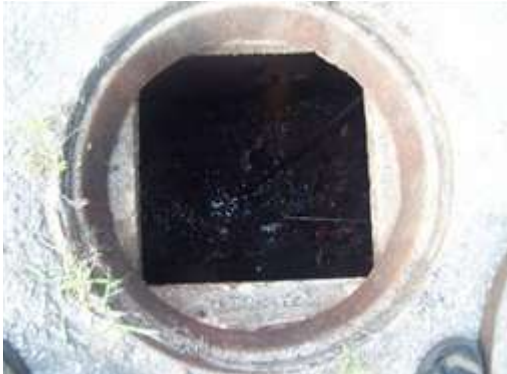
Top View

Frame Offset: **2** (in.) Condition: ☒ Sound ☐ Cracked ☐ Leaks

frame offset

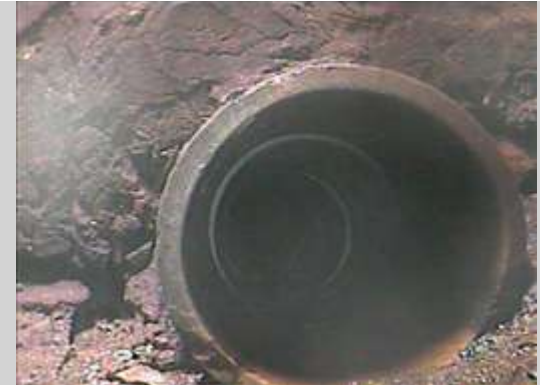
12 O'Clock Outflow

18 in. Circular Gravity Sewer
Pipe Out @ 12 O'Clock

Pipe Material: **Clay** ☐ Pipe Lined

Invert Depth: **8.88** (ft.) Flow Characteristics: **None**

Infiltration: **None** Pipe Seal Cond: **Sound**

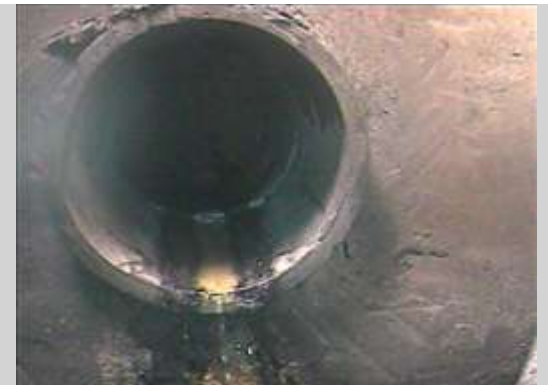
3 O'Clock Inflow

8 in. Circular Gravity Sewer
Pipe In @ 3 O'Clock

Pipe Material: **Clay** ☐ Pipe Lined

Invert Depth: **4.33** (ft.) Flow Characteristics: **None**

Infiltration: **None** Pipe Seal Cond: **Sound**

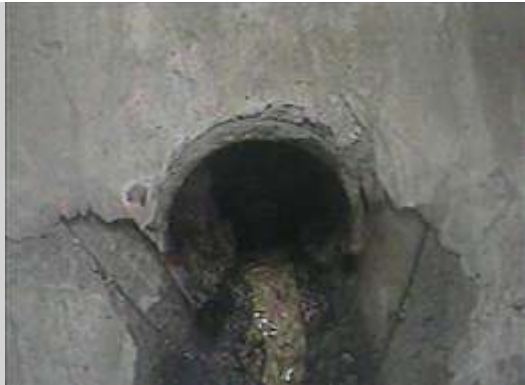
6 O'Clock Inflow

12 in. Circular Gravity Sewer

Pipe In @ 6 O'Clock

Pipe Material: **Clay** ☐ Pipe Lined

Invert Depth: **6.38** (ft.) Flow Characteristics: **None**

Infiltration: **None**

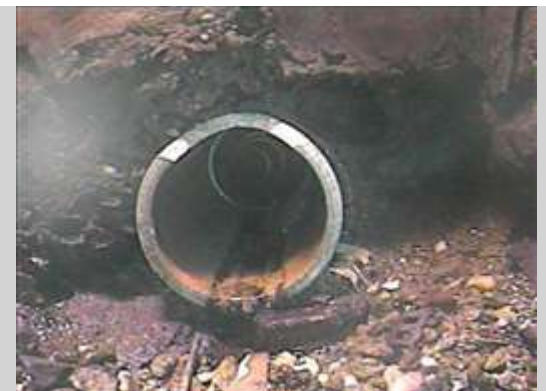
9 O'Clock Inflow

8 in. Circular Gravity Sewer

Pipe In @ 9 O'Clock

Pipe Material: **Clay** ☐ Pipe Lined

Invert Depth: **8.52** (ft.) Flow Characteristics: **None**

Infiltration: **None**
